AEROPRAKT

SAFETY ALERT

No. SA A-22-03

Model: A22LS

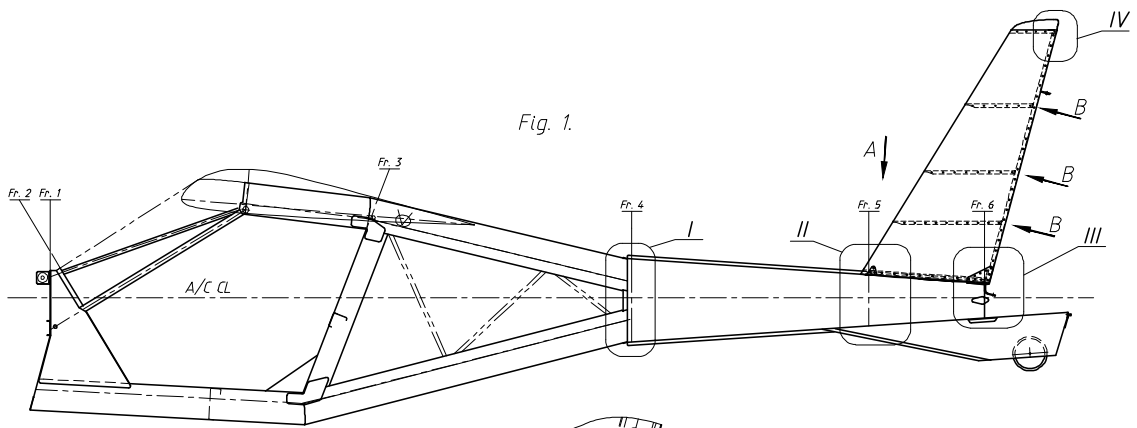
Fig. 1.

It was found out that an intensive operation of the airplane causes elastic oscillations of the fuselage tail boom skin and stabilizer deforming the tail boom skin in the area of the stabilizer attachment fittings. Those deformations which may result in dents and fatigue cracks in the tail boom skin in the area of the stabilizer attachment fittings. To reduce the probability of creation of the dents and cracks it is necessary to increase the stiffness of the tail boom skin in the area of stabilizer attachment fittings using the reinforcing pads. **It is strongly recommended to avoid the resonance vibrations of the main landing gear.**

1. Inspect the tail boom for dents and cracks in the specified area (see fig. 1).

If dents/cracks are found it is necessary to perform the repair work according to p. 3.1.2, otherwise carry out inspection regularly.

- 3.1. Straighten the tail boom skin in the detailed view III (see fig.1).
