AEROPRAKT

SERVICE BULLITEN

No. SB A-32-02

Model: A-32

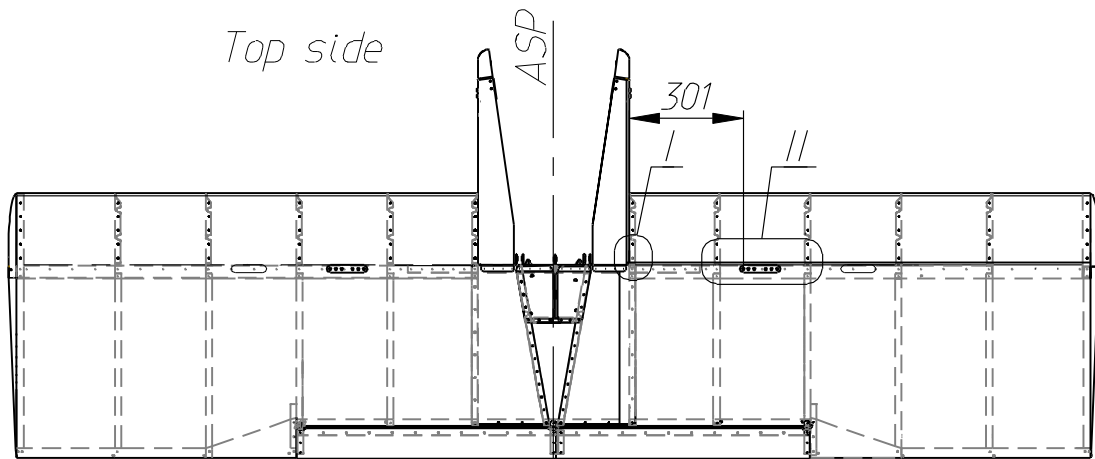
Fig. 1

Inspect the AMHT in the area of mod kit parts installation (see detail views II and IV in fig. 1 and 2) for dents, deformation and cracks. If any damage is found in the above mentioned areas consult the manufacturer.

- 1.1. Mark 2 holes (1 per righthand/lefthand side) on the top side of the AMHT at 301 mm distance as shown in fig. 1 and 3.
- 1.2. Drill the 2 marked holes with &3.3 mm drill bit.
- 1.3. Install the doublers (1) on Cleco fasteners symmetrically about the aircraft symmetry plane (ASP).
