# **AEROPRAKT**

## **SERVICE BULLITEN**

### **No. SB A-32-07**

**Model: A-32**

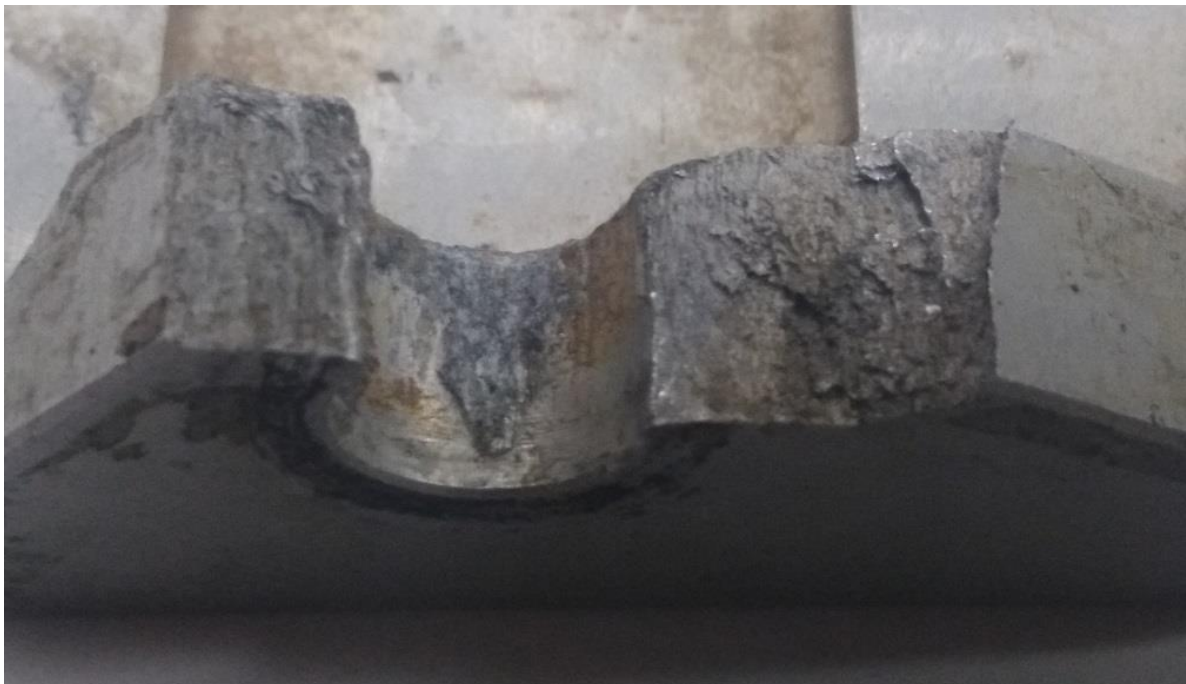
**2. Photo 1**

In conditions of high humidity and insufficient lubrication of the inner surface of the bracket hole (see photo 1) in the area of contact with the steel bolt, intergranular corrosion may appear, which affects significantly the bracket strength and may cause its disintegration.

**If case if the intergranular corrosion is detected in the bracket, stop operation of the aircraft until replacement of the bracket. If there is no corrosion, continue to operate the aircraft with the bracket available, checking it for corrosion at every 100-hour inspection.**
