AEROPRAKT

SERVICE BULLITEN

No. SB A-32-08

Model: A-32

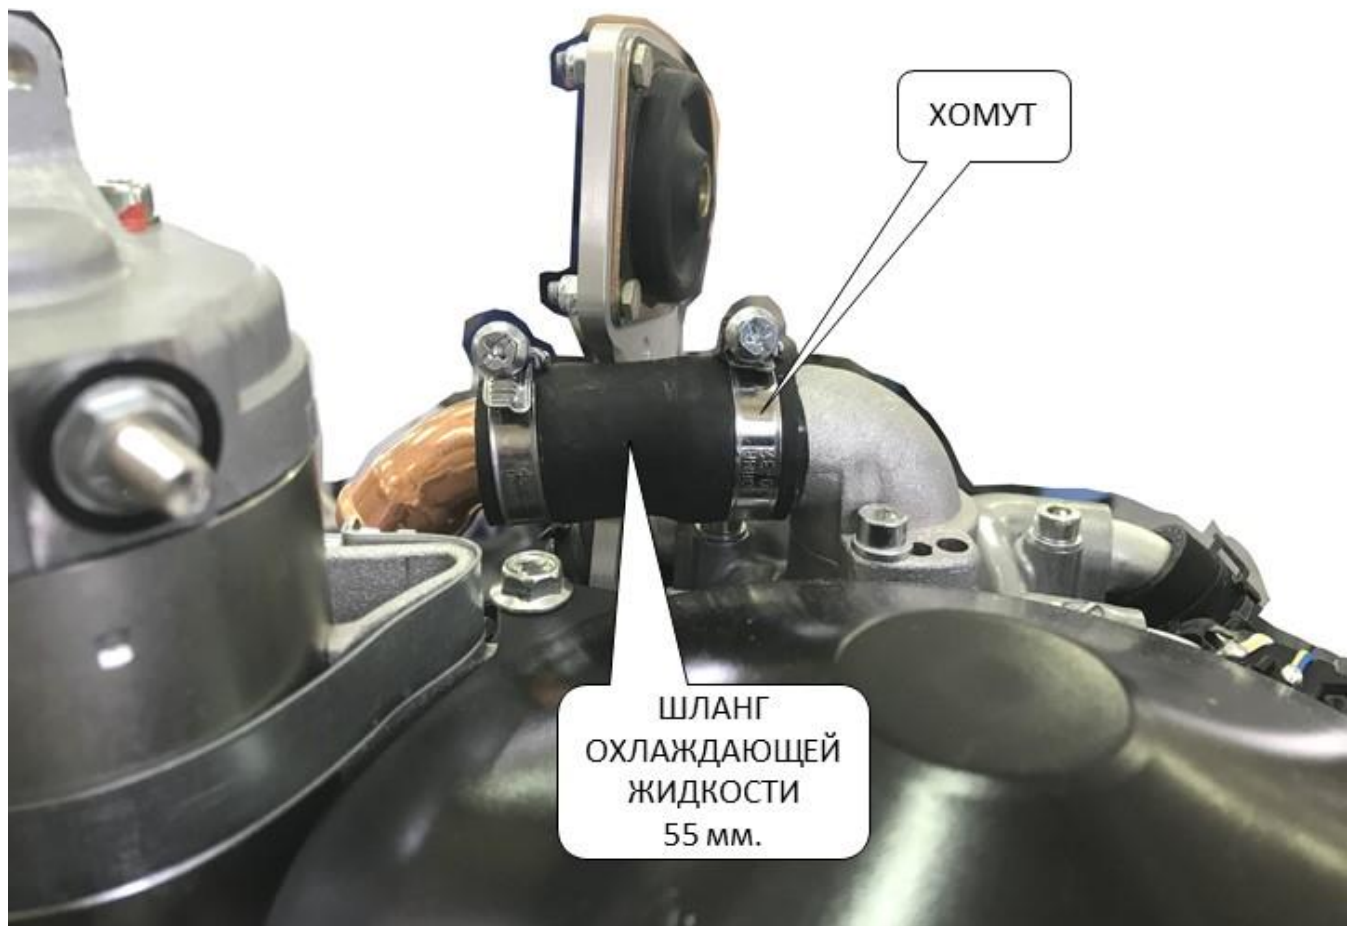
Cases of spontaneous disconnection of the coolant supply hose from the inlet pipe of the water pump (see Photo 1).

- ▲ Failure to perform this work will result in engine overheating and failing in flight!

Screw-clamp attaching the water hose on the engine cooling system water pump inlet. See photo 1.

3.2) Tighten the screw-clamp shown in Photo 1 to 4 N·m (3 lb·ft) torque.
